Town of Arlington

FINAL REPORT

ADA Self-Evaluation (as basis for Transition Plan)

Prepared by
Institute for Human Centered Design
December 15, 2014

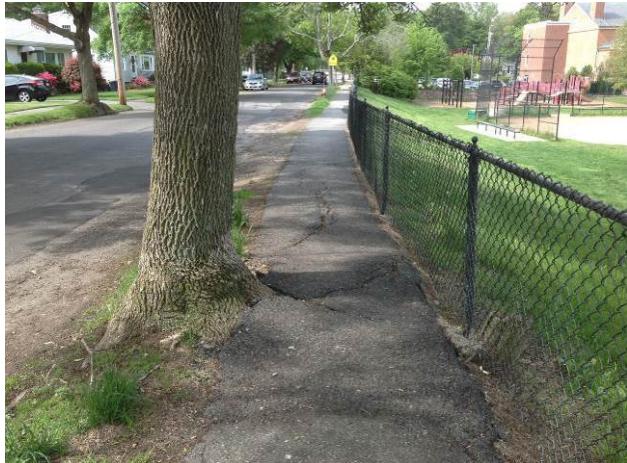
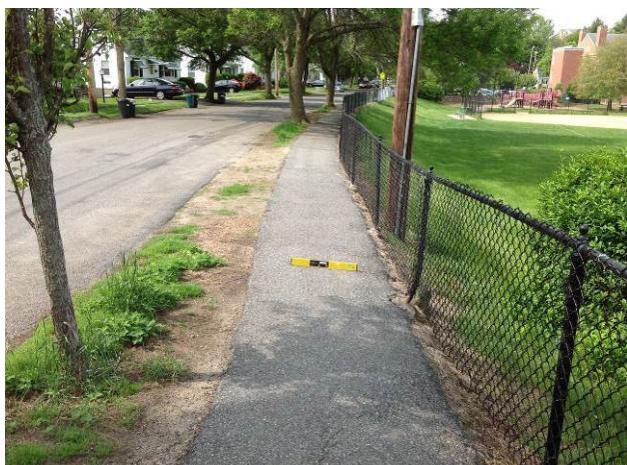
(Photos 2 and 3)

All of the issues described above negatively affect the pedestrian approach to this facility from the nearby public transit stop at Mystic Street @ Columbia Road.

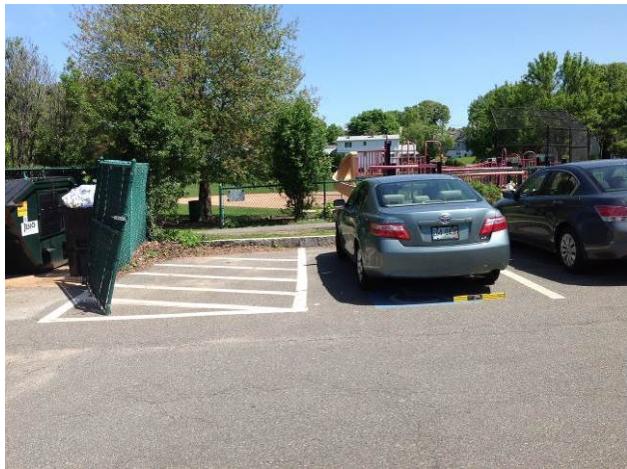
Photo 4

In the parking lot off of Stowecroft Road, one parking space designated as accessible is provided adjacent to this facility. Not only is the required parking sign missing but also the parking space is slightly steep. (Photo 4)

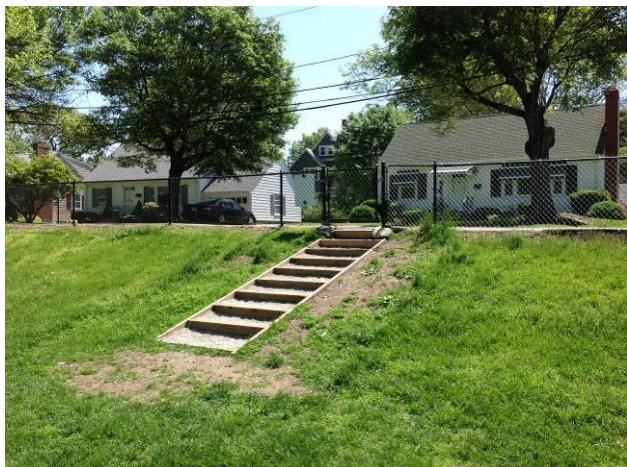
Photo 6

Additionally, the stairway leading to the baseball/little league and soccer fields does not have compliant surfaces and railings. Further, this inaccessible point of entry does not offer an ADA-compliant sign directing the public to the accessible point of entry 150 feet away. (Photo 6)

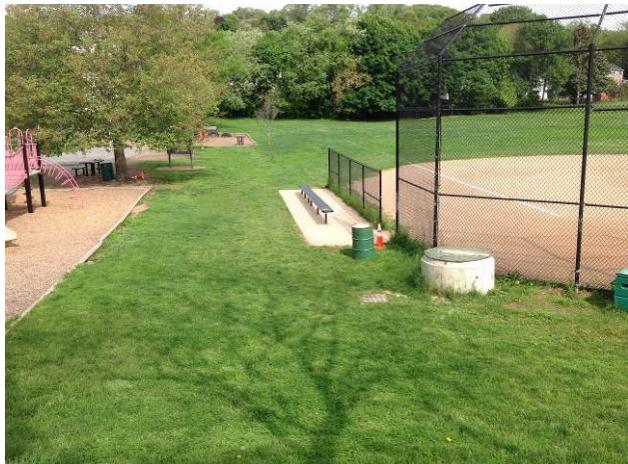
Photo 7

Although an asphalt walkway is provided between the point of entry at the parking lot and one playground and the basketball court, no accessible route is provided between either point of entry and the softball/little league and soccer fields. (Photo 7)

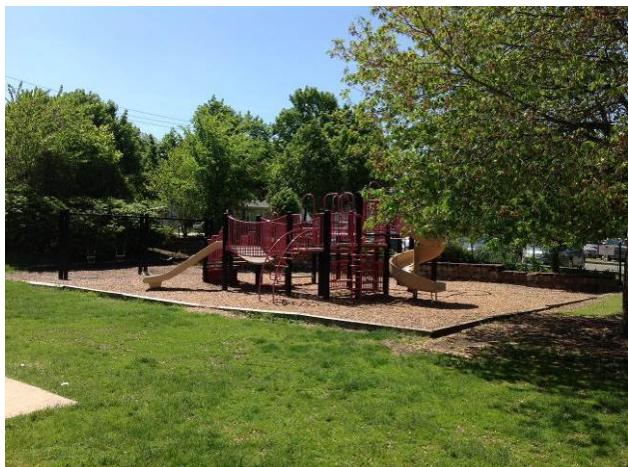
Photo 8

Although the wood fiber surface is currently well maintained and has compliant slopes, no accessible route is provided to the playground on the East side of the basketball court. (Photo 8)

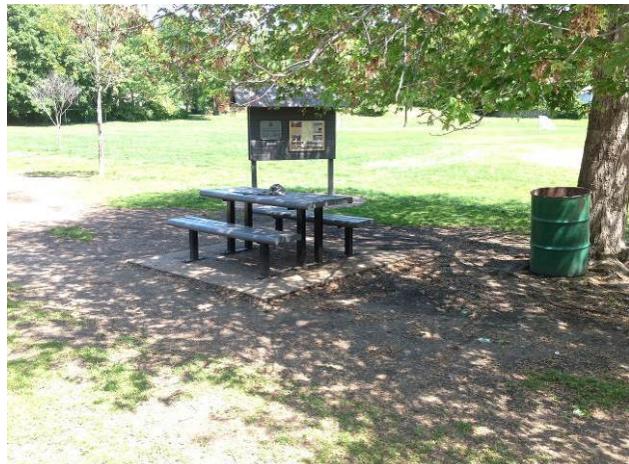
Photo 10

Three picnic tables are provided near both playgrounds: one near the parking lot, the other near the playground on the West side of the basketball court. None are accessible or are provided on accessible route. (Photo 10)

- 8 Tables:** Replace the picnic table with an ADA-compliant amenity and extend the asphalt walkway to it.
- 9 Benches:** Relocate one of the benches to an accessible area or install an accessible walkway to it.

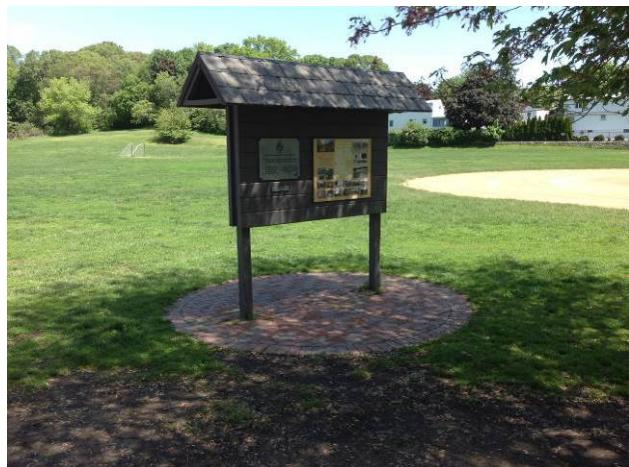
Photo 12

A bulletin board is provided at the edge of the grassy field; however, it is not located within an accessible route. (Photo 12)

- 1 Portable Toilet:** Relocate the portable toilet along the existing walkway or extend the asphalt walkway to it.
- 1 Bulletin Board:** Consider extending the asphalt walkway to the bulletin board.

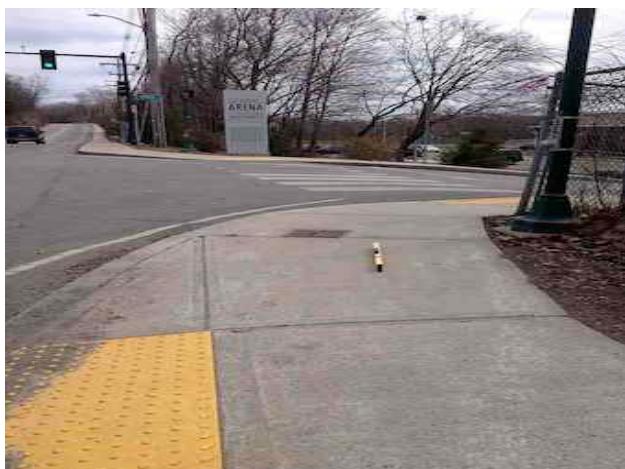
Photo 1

Sports Complex crosswalk areas at Summer St. & Ryder intersection are not connected to an accessible path of travel leading to Buck Field entrance. (Photo 1)

Recommendation: See Sports Center Complex, Site Arrival Survey, Part C.

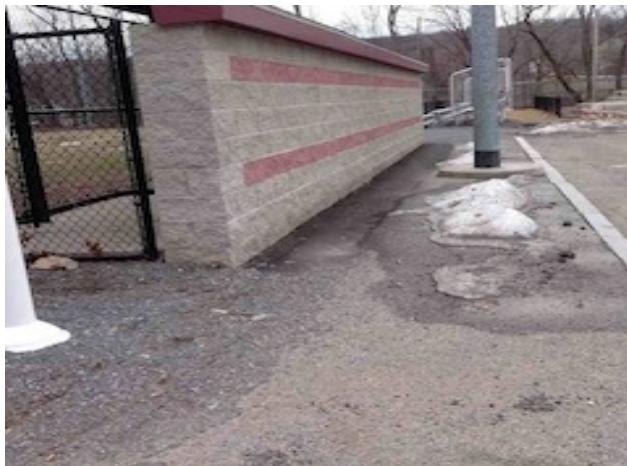
Photo 2

Sidewalks adjoining Buck Field facility areas contain many obstructions, uneven and warped surface areas, are made of dissimilar materials causing vertical level changes, and do not provide accessible path of travel to any facility areas, elements and amenities along the exterior approach and entrance routes. (Photo 2)

There needs to be at least 1 accessible path of travel providing a connection between the Sports Complex facilities and all exterior areas, elements and amenities, including accessible entrances, accessible parking spaces, seating amenities, informational sign installations, and trash receptacle.

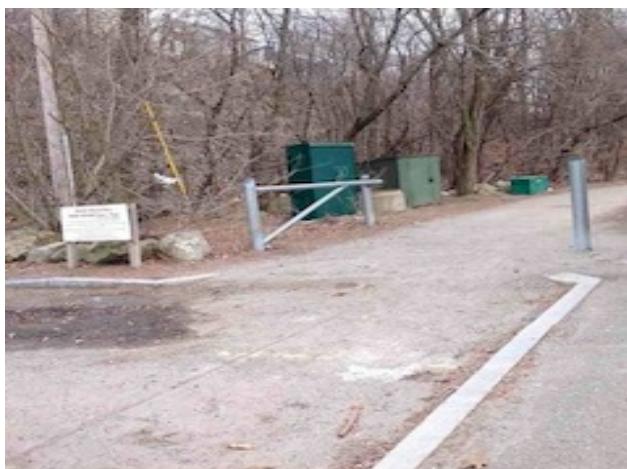
Photo 4

The main entry is not along an accessible route because the route is not firm, stable, level or slip-free. (Photo 4)

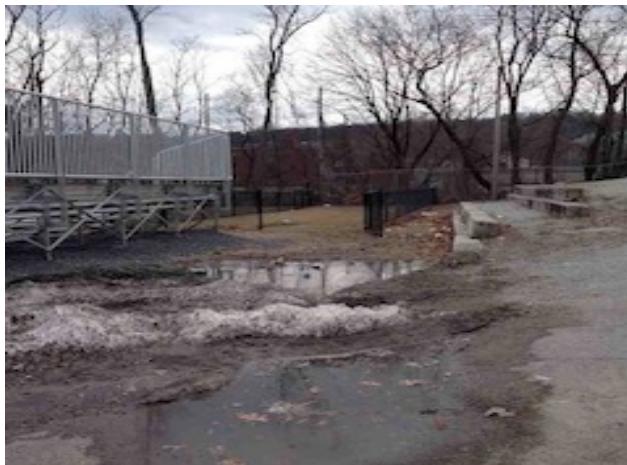
Photo 5

The Batting Practice area approach and entrance is not firm, level or slip free; and it is near old crumbling staircase infrastructure, which provides an additional safety hazard. (Photo 5)

There is not at least one accessible route linking all program areas offered at Buck Field together and to the at-grade entrance.

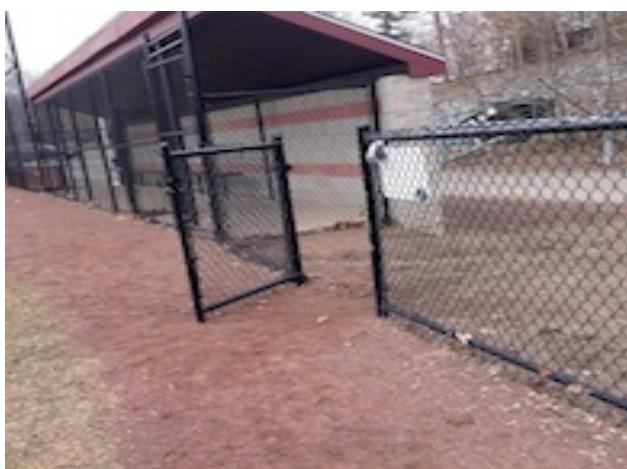
Photo 6

Team Dugout/clubhouse ground surface is a mixture of gravel and hardtop with no pave accessible route available at this time. (Photo 6)

Alterations were completed without provision of an accessible route to and within the clubhouse and team seating areas. (See Photo 6)

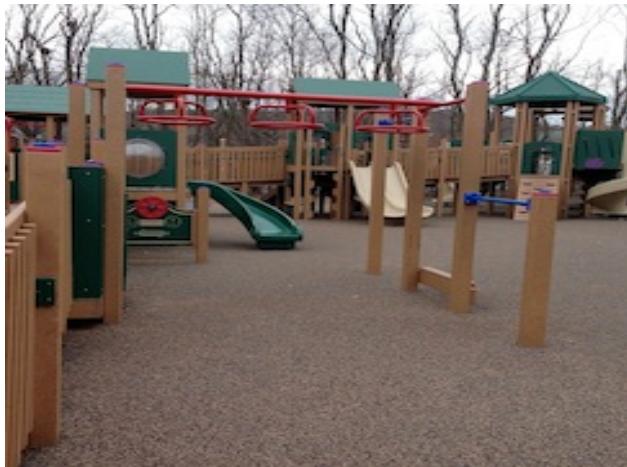
Photo 11

The large accessible composite play structure provides an accessible elevated route to over 90% of the elevated play components and provides many types of exciting and integrated play opportunities along the way. When the accessible route issues are connected between and within these two play areas (i.e., cross slopes not exceeding 2.08%), this playground will indeed be a model of an exciting and integrative program. (Photo 11)

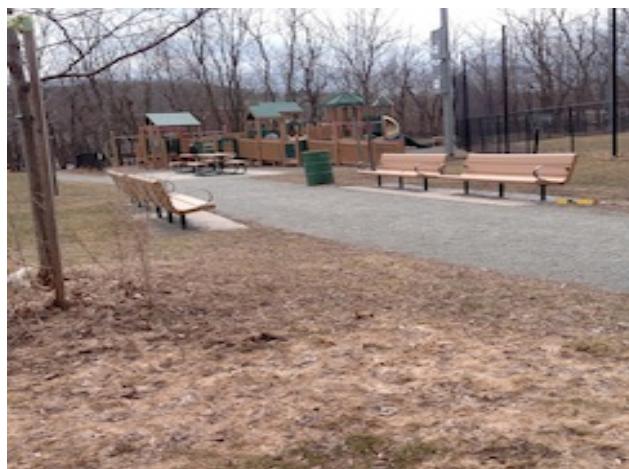
Photo 15

A picnic area with two tables is provided at the front of the playground area and there is a picnic table at the back of the playground area as well, near the fence. There is also a picnic table located outside the fence near the team clubhouse, which clutters an already narrow and excessive sloped route from adjacent parking spaces to facility entrance. There are no accessible tables provided; however, there is adequate level ground space for accessible seating alongside the tables in the front. (Photo 15)

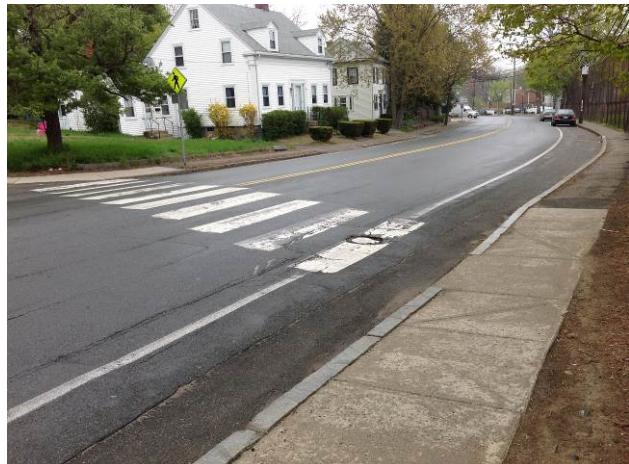
Photo 1

At the intersection of Summer Street and Victoria Road, a highly visible pedestrian crosswalk leads to one of the points of entry to this facility. The curb ramp is inadequately constructed and is missing the top level landing. (Photo1)

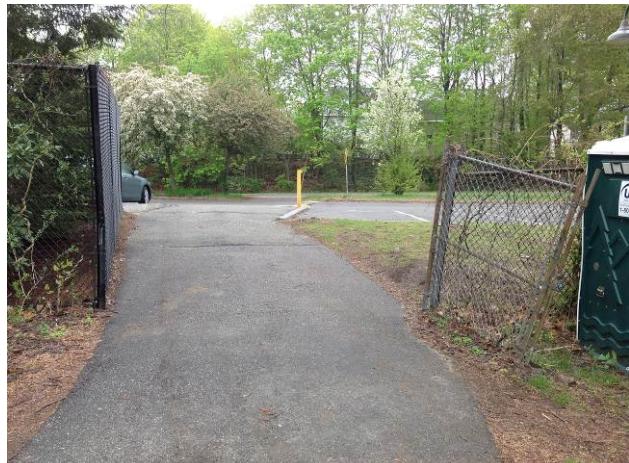
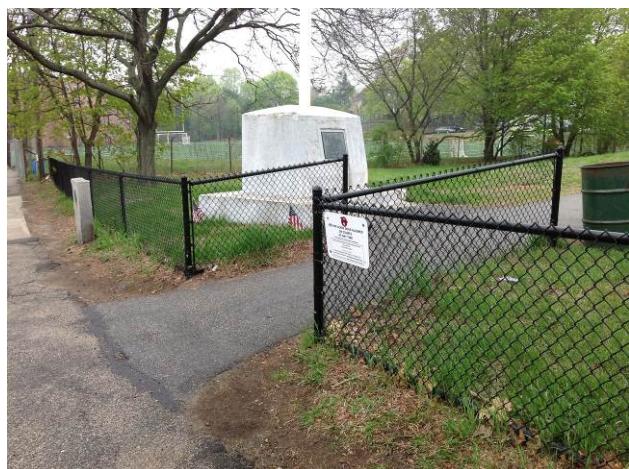
There are two points of entry in this facility: one on Summer Street and one on Russell Place / bike path access point. Both points of entry have walkways with excessive slopes. (Photos 2 and 3)

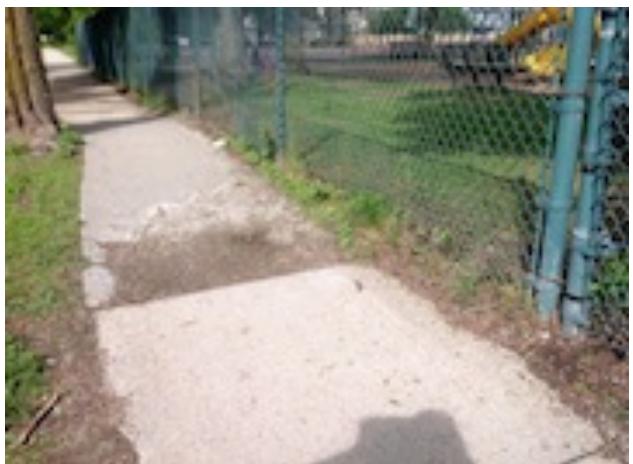
Photo 3

Oxford St. sidewalks are in disrepair with large panel gaps, level changes, varying widths, excessive slopes and not smooth. (Photo 3)

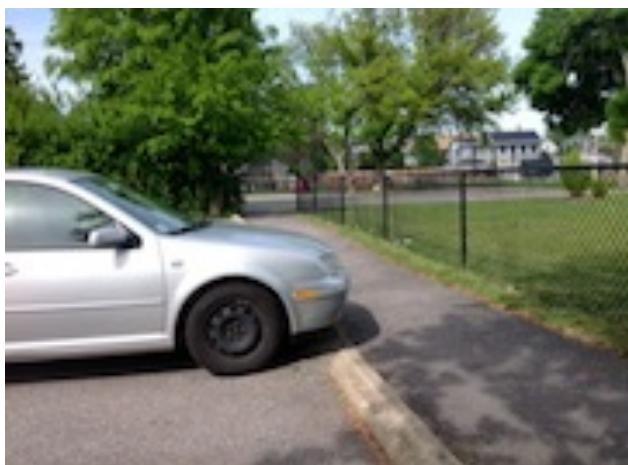
Photo 4

The reserved adjacent parking lot includes a back paved path connected to facility's hopscotch/four-square court and interior walkways. This path requires maintenance for level changes and slope issues. (Photo 4)

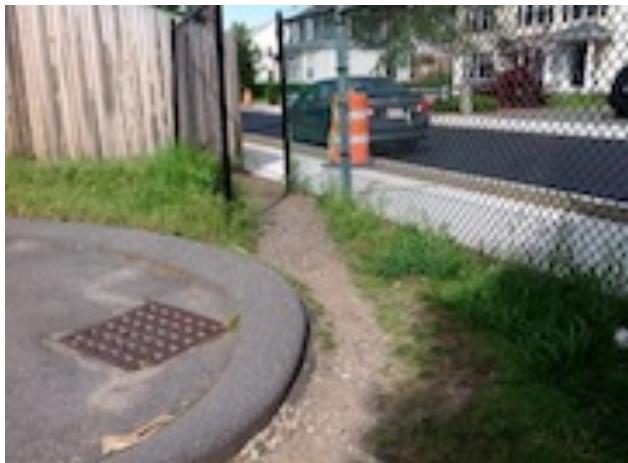
Photo 6

The entry from Oxford is inaccessible and not safe. The entry point is located at a narrow fence opening and includes a dirt path that is narrow, not smooth and level, and that is overlapped by the high level changes inscribing the Basketball/Singles Tennis court area.

While this entrance from Winter Street remains inaccessible, directional signage should be placed at the sidewalk entrance directing users to the nearest accessible route into facility. (See Photo 6, p. C-26)

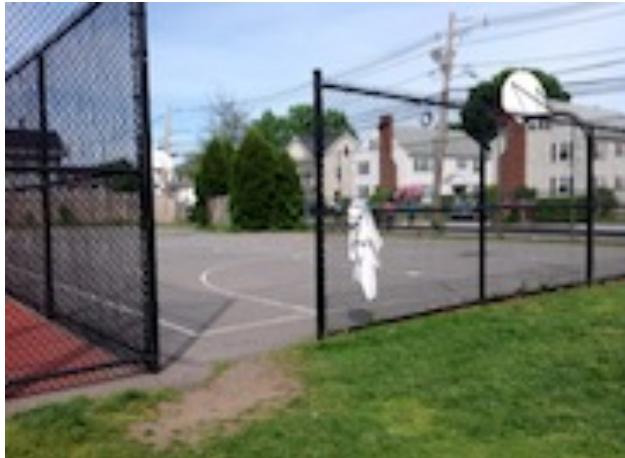
Photo 8

The paved interior walkway does not provide an accessible connection into the bordered playground. (Photo 8)

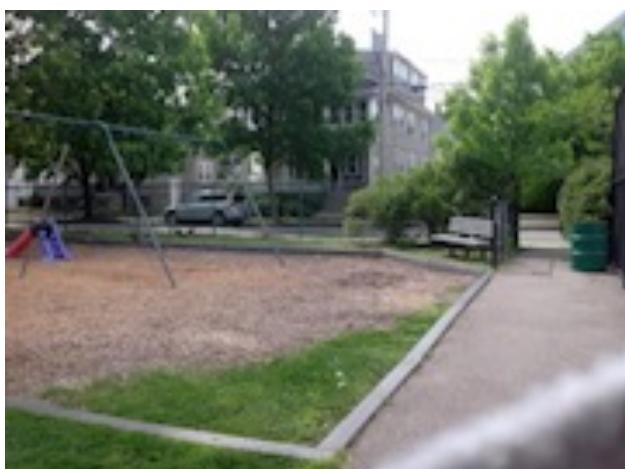
Photo 9

The play area with loose-fill ground surface materials does not include an accessible point of entry due to the border fully surrounding the perimeter of this play area. (See Photo 9, previous page)

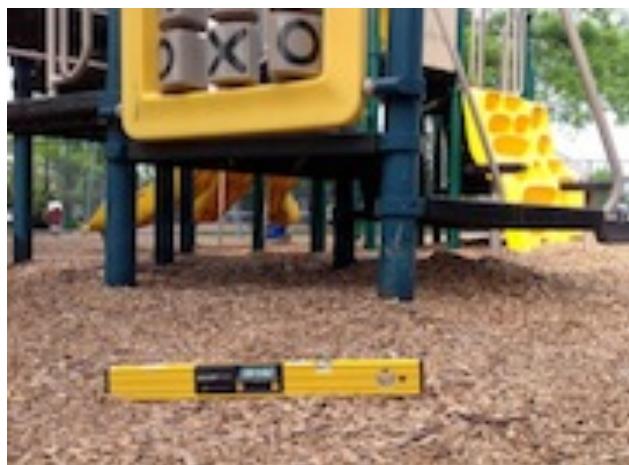
Photo 10

The playground loose fill materials have excessive cross slopes at some entry/exit points, such as at the spring rocker, at the bottom (exit point) of some slides, and at some transfer steps on the large composite structure. These ground surface issues are a current barrier to accessible circulation to and between ground play elements. (Photo 10)

a. If only loose fill ground surface materials are used, a high-frequency maintenance policy needs to be in place to ensure accessibility of ground surface materials in play area use zones through all seasons.

b. If ground surface materials will be replaced: consider adding impact-attenuating tiles within the playground areas to provide accessible routes and clear ground spaces to all entry/exit points of ground play elements, including swingsets, spring rockers and play structure.

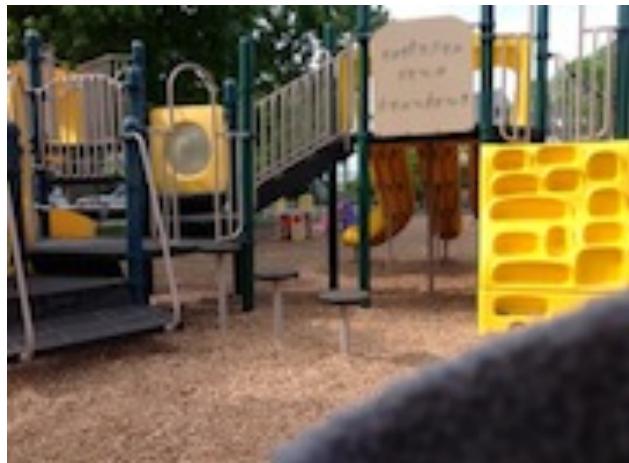
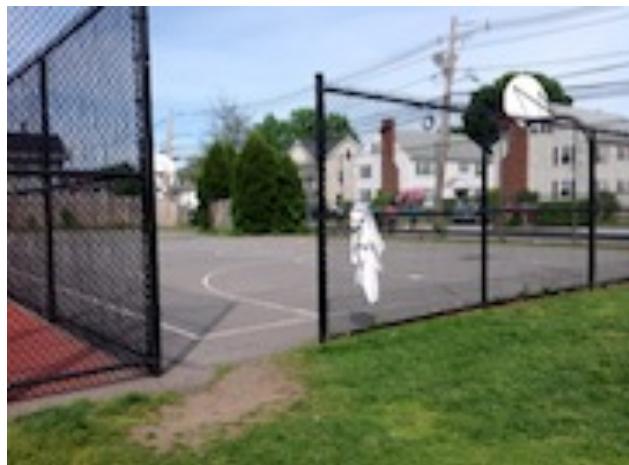
No accessible elevated route to elevated play components is currently provided. (Photo 12)

There is a full Basketball Court and a singles tennis or badminton court located on the Winter St. side of facility. There is no accessible point of entry into and through this area from Winter St. sidewalks, and there is no accessible route to this area from the field. (Photo 12)

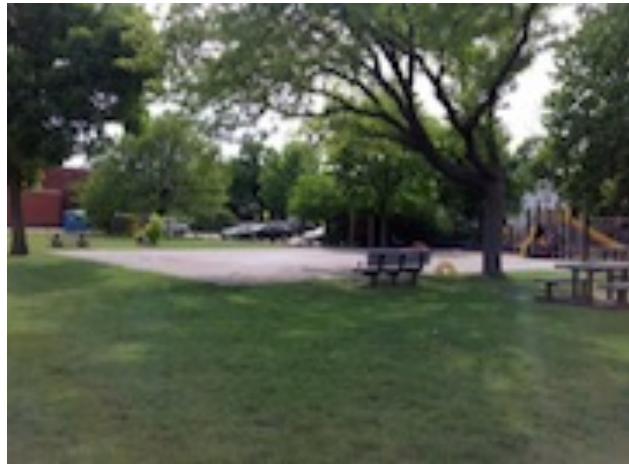
Photo 13

The Open field is one of the Town's scheduled soccer practice fields, and provides a lovely grassy space at other times. Picnic tables are in the field and benches are along the field perimeter. The field is adjacent to the ground games court, which is connected to the accessible interior walkways. (Photo 13)

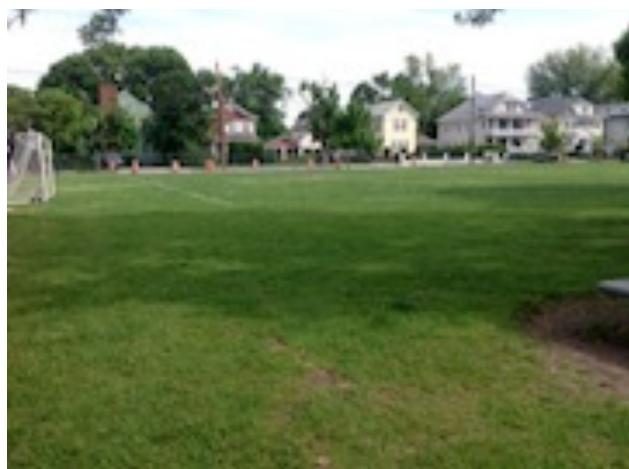
Photo 14

The perimeter of the field play areas and elements and amenities supporting field activities (such as benches, picnic tables and the portable toilet) are not connected along at least one accessible route with the playground, Basketball court, and accessible entrance to facility. (Photo 14)

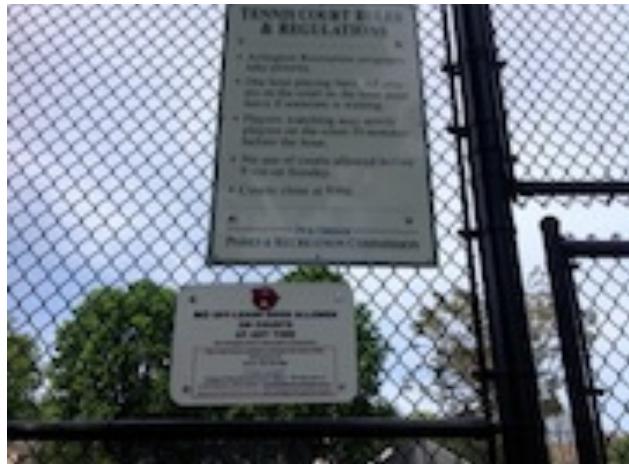
Photo 17

Informational Signage regarding Tennis Court rules is posted on the fence. This information is mounted too high for comfortable viewing.

There is no information regarding how to obtain this information in alternate accessible formats.
(Photo 17)

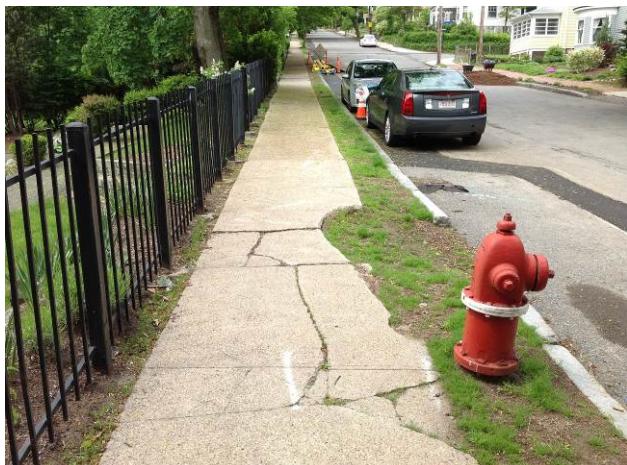
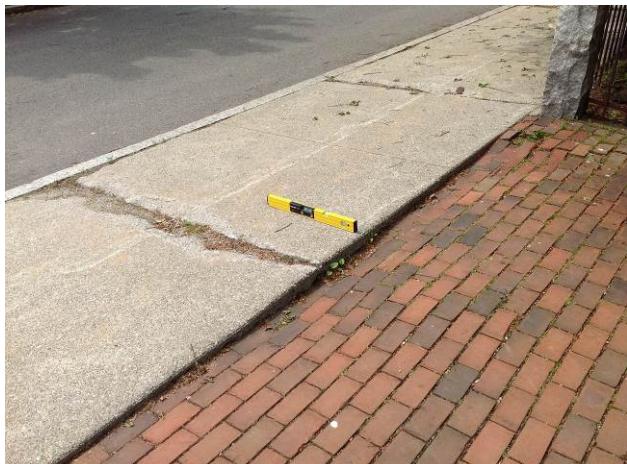
The sidewalks along Robbins Road and School Street are in poor condition. Not only is section of the sidewalk along Robbins Road extremely deteriorated but also the sidewalk along School Street has excessive cross slopes and deteriorated control joints. (Photos 1 and 2)

Repair the sidewalks along Robbins Road and School Street (about 100 feet).

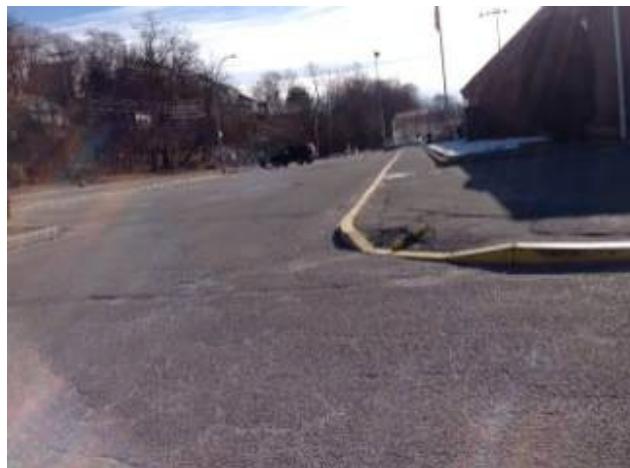
Photo 4

The apex curb ramp at the facility sidewalk facing Summer St. Park is inaccessible, with steep running slopes, excessive cross slopes, and missing flared sides. The gutter and sidewalk transitions have excessive changes in level. Curb ramp is unusable. Due to its excessive slopes, water and ice accumulation are probable. (Photo 4)

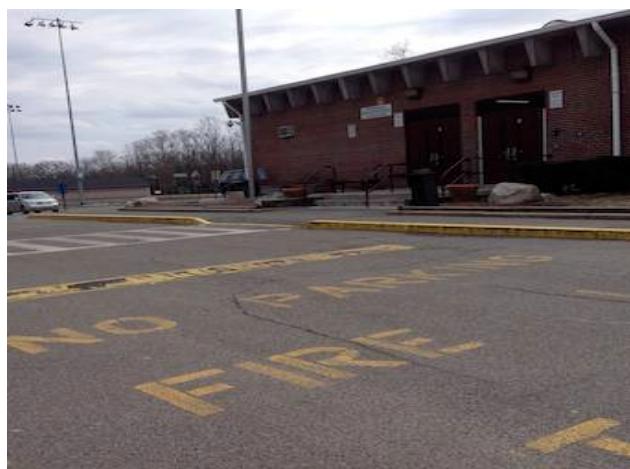
Photo 6

The facility is surrounded on three sides with a walkway that does not provide accessible connections to the parking lot crosswalks, the entrance doors, the Arena emergency exit doors, or the ramp that leads into the Recreation Department office. This inaccessible sidewalk has warped, uneven surfaces and requires redesign and reconstruction to come up to code. (Photo 6)

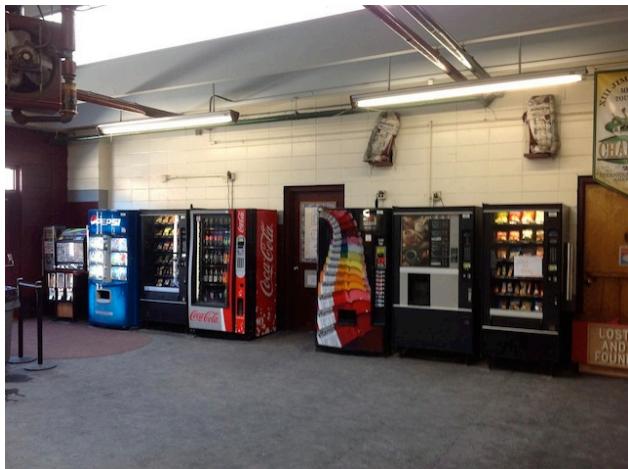
Photo 14

The location of the vending machines at the entrance area may create a crowded and impassable condition during spectator events. (Photo 14)

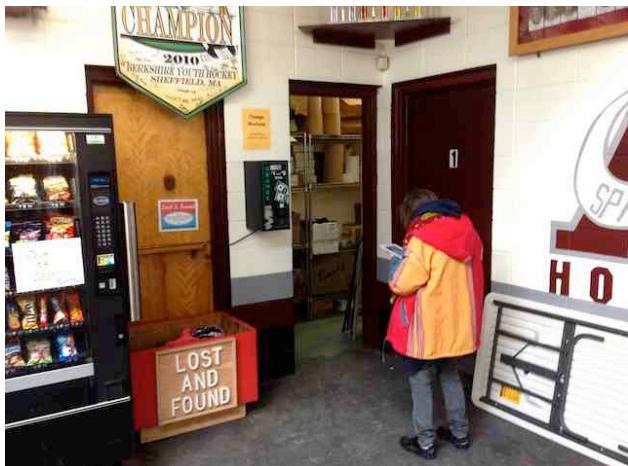
Photo 16

The Main Room/Lobby area also contains multiple tripping hazards¹⁵, which include:

- Floor mats at entrance, which need to be securely fastened to minimize tripping hazards;
- Folding board signage and pole signage;
- Lost & Found box, which has an edge, not aligned with side edge of adjacent Vending machines. (Photo 16)

- Securely fasten floor mats at Lobby entrance.
- Replace floor mats within Arena circulation paths that are in the general path of travel and/or in the path of travel to emergency exit doors where the edges are higher than 1/2 inch, beveled. Securely fasten all mats.
- Relocate folding board signage and pole signage to be outside the path of travel.
- Relocate Lost & Found box to an area where it does not protrude into the path of travel-- including at doors and rooms where the public receives services.

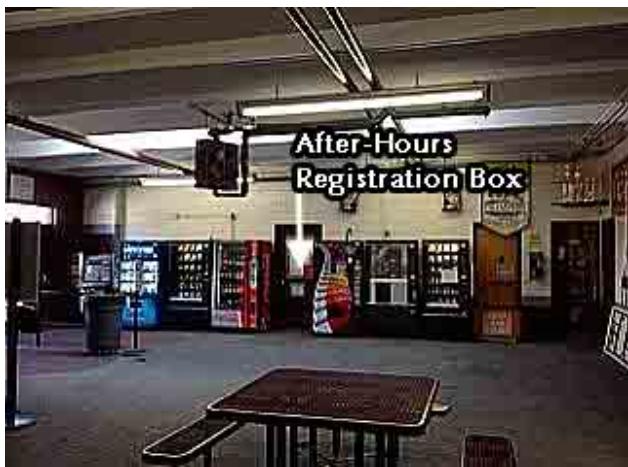
Photo 18

The Recreation Office After-Hours Drop-Off box located on the Department door between the 4th and 5th vending machines is not accessible because it is within a shallow recessed area that does not provide for unobstructed clear floor space for forward or parallel approach. (Photo 18)

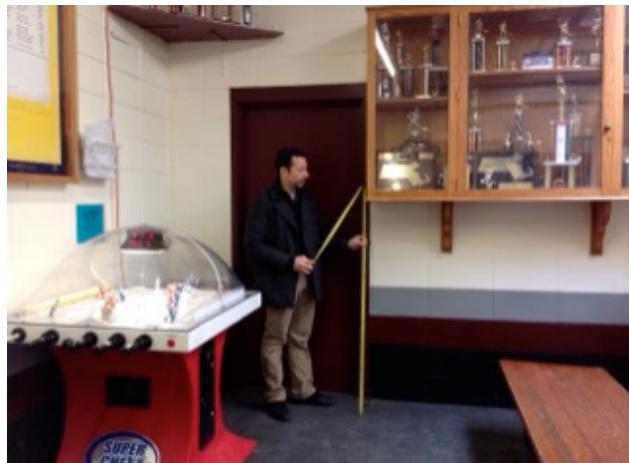
Photo 20

The **foosball game** is not accessible because there is not enough clear floor space for forward or parallel approach. (Photo 20- also shows protruding object measurement.)

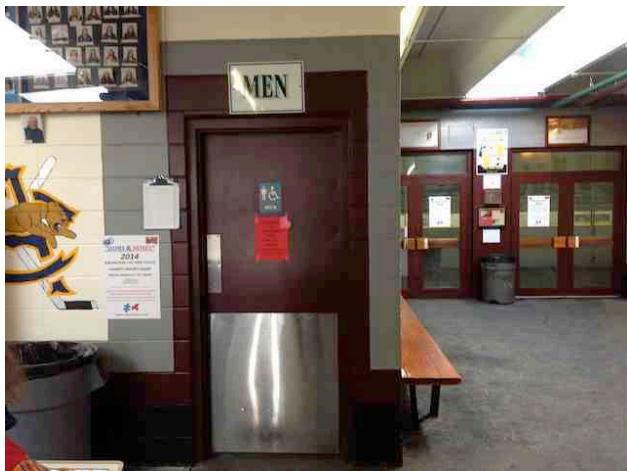
Photo 22

Access to the Women's and Men's Room doors is impeded because of multiple protruding objects against the walls. (Photo 22)

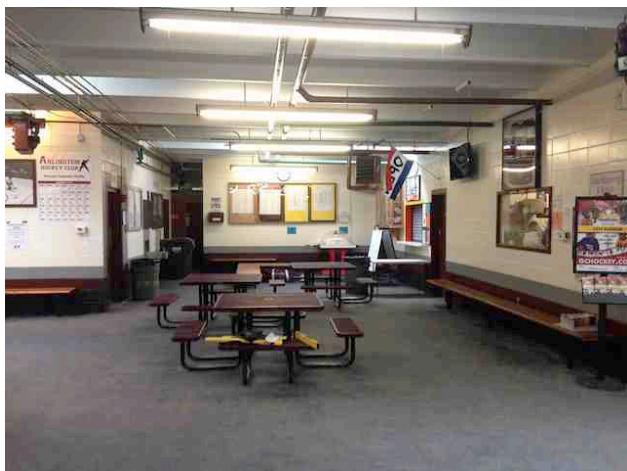
Photo 24

Three 8-top Tables and 6 Benches (4 against wall) are provided. At least one or 5% accessible tables not provided. Knee clearance not provided at tables. No free-standing benches have backrests or armrests. (Photo 24)

Tables, benches and amenities should be arranged to be along a continuous accessible route with at least 36 inches width to all areas and elements at facility.

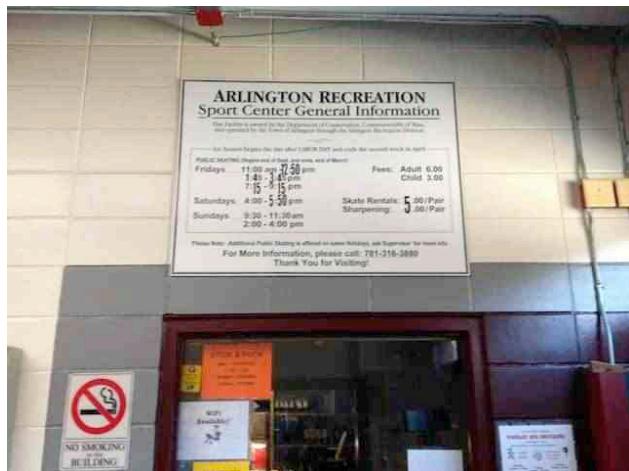
Photo 25

At the entrance and throughout the Main Room, multiple signs give a cluttered appearance. Important signage regarding facility and services information is mounted too high. (Photo 25)

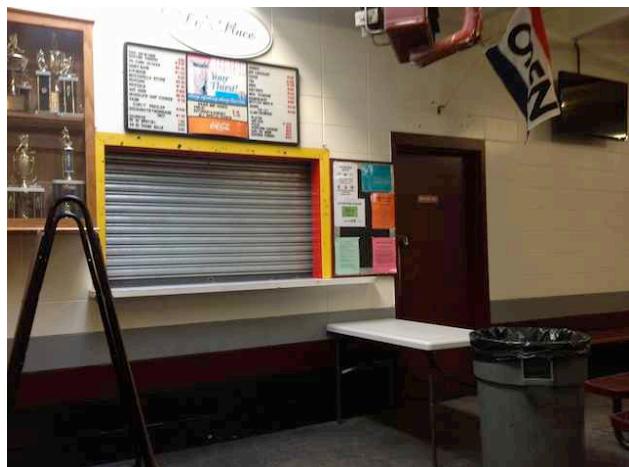
Photo 26

Snack Bar Menu is also not mounted within viewing range. It is recommended to have alternate format menus readily available upon request. This includes Large Print formats. (Photo 26)

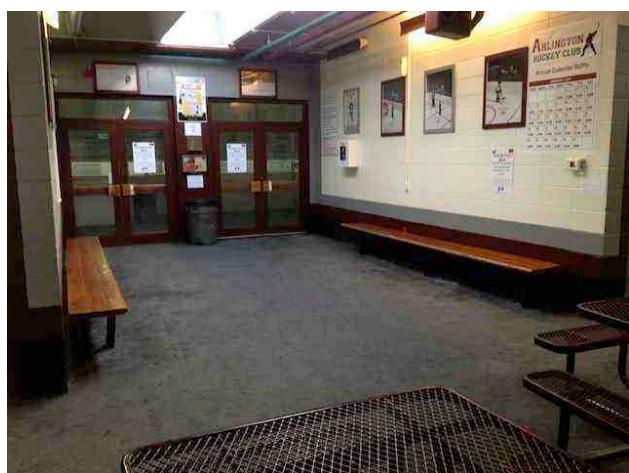
Photo 27

From the Main Lobby to the Sports Arena, benches on either side and a box located on the wall act as protruding object because there is no protection or barriers to allow visually impaired persons to detect these barriers within the route. (Photo 27)

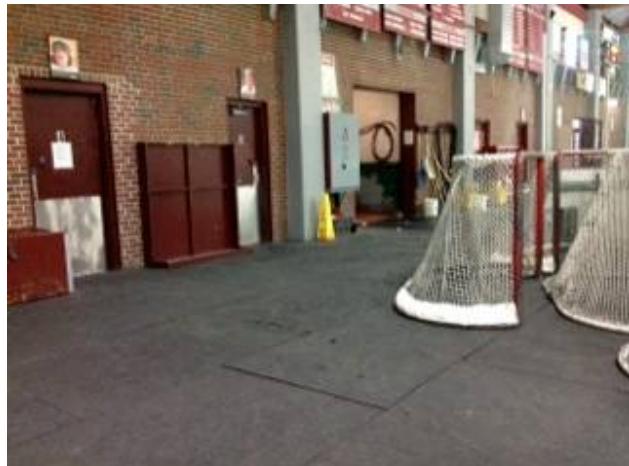
Photo 28

Multiple objects against walls protrude over 4 inches into the circulation route. All objects that are mounted on walls between 27 - 80 inches from floor with no floor-to-bottom detectable shielding need to be made cane-detectable, with shapes that align pedestrians along general public circulation paths. (Photo 28)

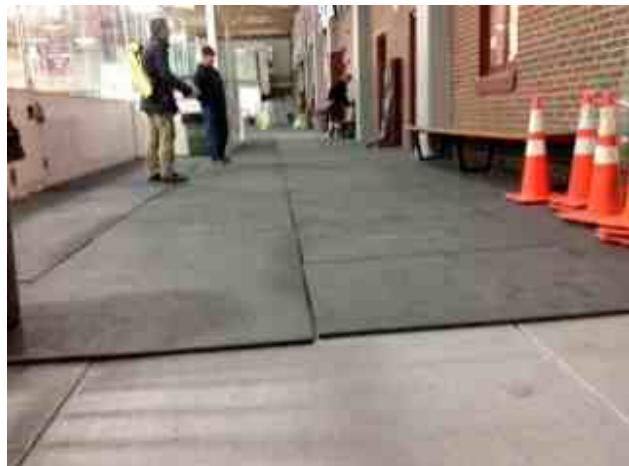
Photo 29

Floor mats have edges that exceed 1/2 inch beveled, and need to be securely fastened to prevent tripping hazards. (Photo 29)

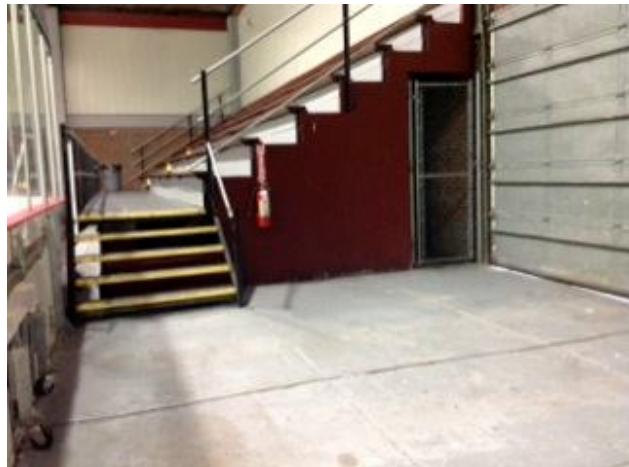
Photo 30

There are no signs designating Team Benches and Bleachers. An area to the right of the rink is separated from the rest of the fixed spectator seating and may be an area used for team meetings. (Photo 30)

Wheelchair seating areas need to be an integral part of all seating plans, including where teams gather, meet and function together. The wheelchair-accessible seats should adjoin the accessible route that also serves as a means of accessible egress in case of emergency.

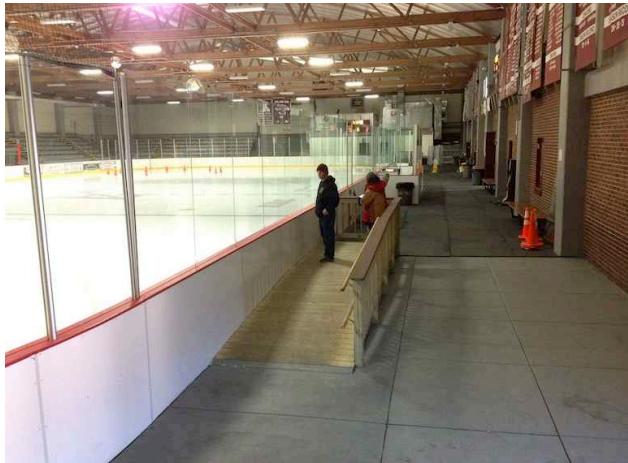
Photo 32

A small ramped platform was recently constructed to seat three wheelchair users in a row, completely separated from the spectator seating area, and unsafe for the users during any emergency. While this may have been designed with an unobstructed view as a goal, such segregated seating is specifically prohibited by the ADA. (Photo 32)

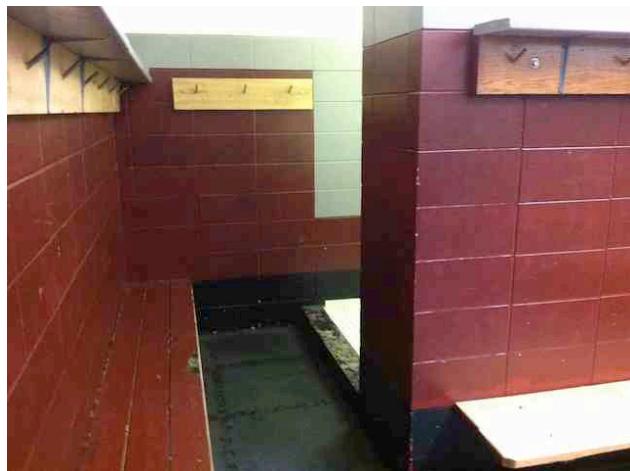
Photo 34

The Skating Rink Arena includes an M & F Team Dressing Room w/ wall benches, hooks and 3-Shower stalls. (Photo 34)

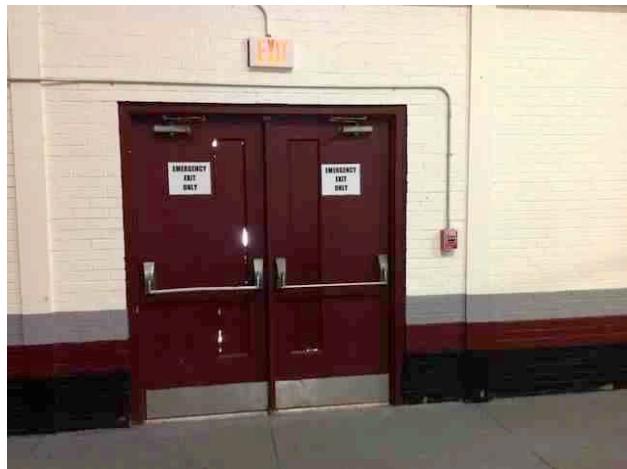
Photo 36

All Emergency Exit doors need to be clearly marked as either accessible or inaccessible. Accessible Emergency Exit doors open to a no-step accessible egress route. (Photo 36)

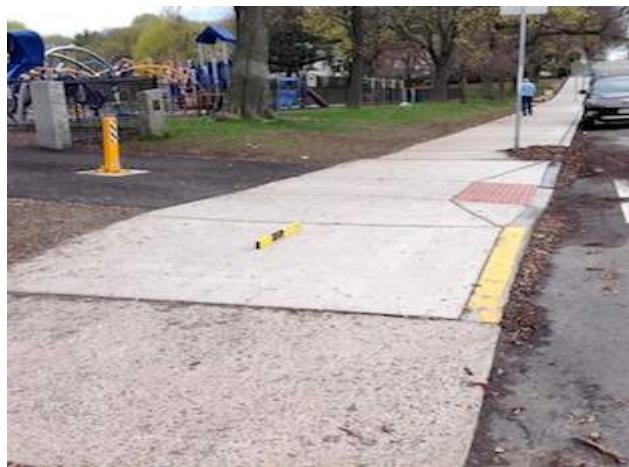
Photo 3

Eastern end of new sidewalk does not blend to compliant slopes where it meets the sidewalk pedestrian zone in front of the school drive-in area (now used for a Four-Square court). (Photo 3)

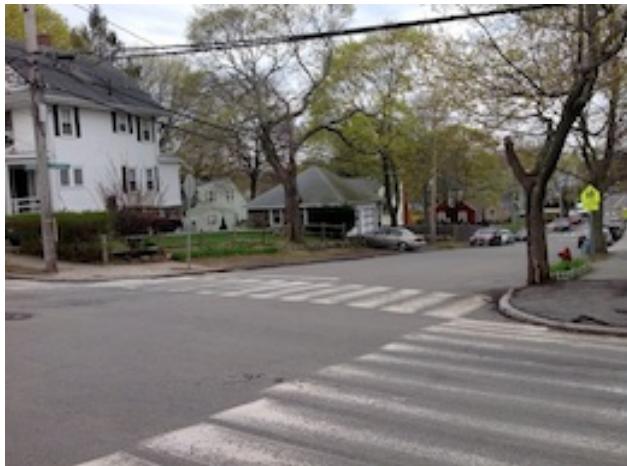
Photo 4

Crosswalks, curb ramps and sidewalks from this location to the new sidewalk panels are in disrepair, inaccessible, and/or missing. (Photo 4)

An accessible route needs to be provided that connects with the nearby public transit bus stop at intersection of Florence Ave. and Wachusett Ave..

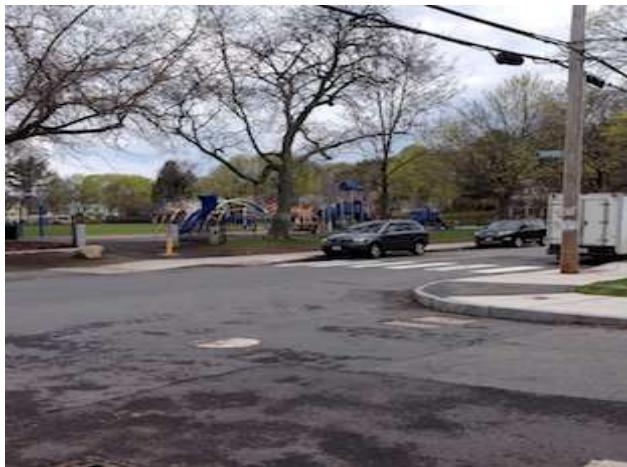
Photo 5

The Renfrew crosswalk entry point includes a walkway with noncomplying slopes. (Photo 5) The east entry from school has excessive run slopes.

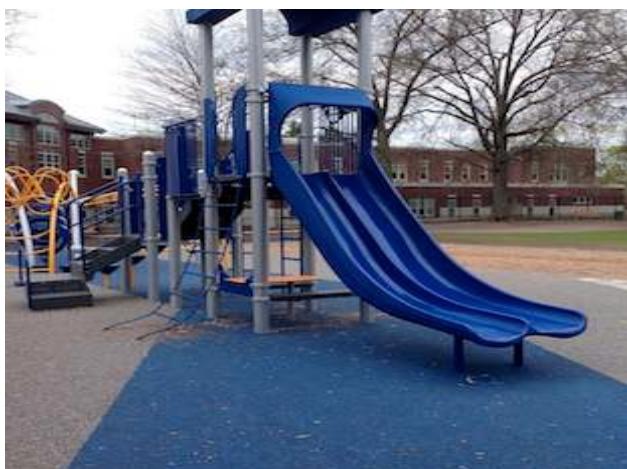
Photo 10

The wood fiber surface under the swingsets is currently well maintained with compliant slopes. The poured rubber "circuit route" allows unrestricted and accessible access to the transfer steps on the play structures and to all ground play elements. This route also connects walkways at both entry points.

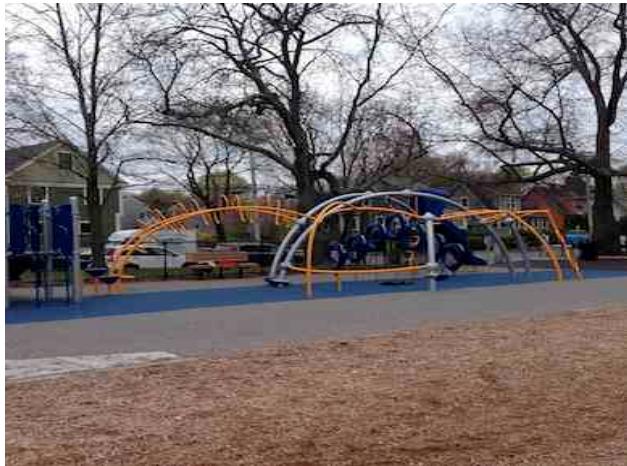
Photo 11

Neither composite play structure includes an elevated accessible ramp. Both structures include transfer stations that provide stepped access to over 50% of elevated play components.

The climbing and swinging structures and the distinctive zip line are play elements for children 5+ that do not provide accessible opportunities. (Photo 11)

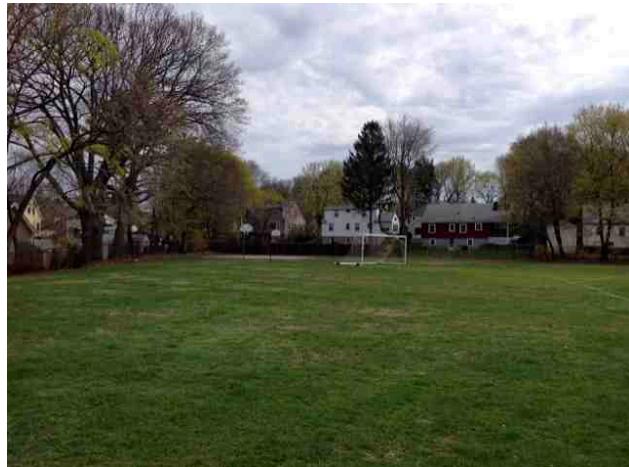
Photo 14

There is a basketball court at the NW corner of facility. It is not located along an accessible route. (Photo 14)

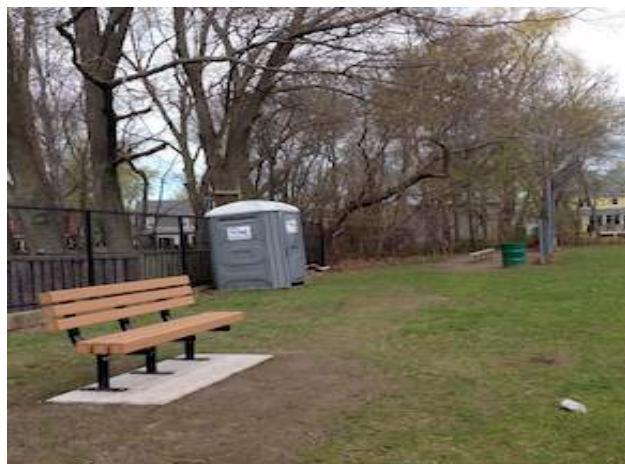
Photo 19

Portable toilet has accessible dimensions but is not located along an accessible route. The threshold height is excessive due to a slight tilt of the amenity. (Photo 19)

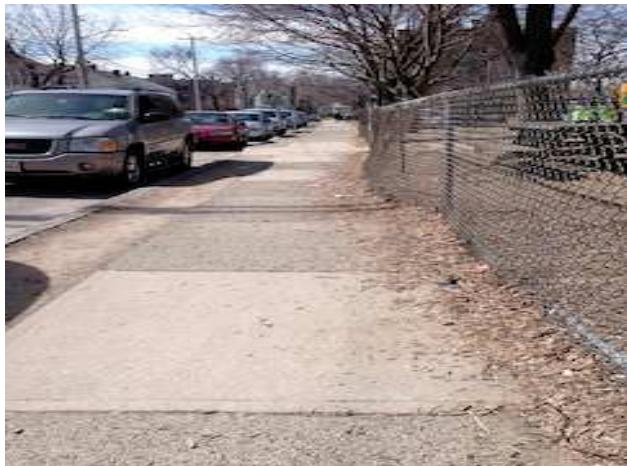
Photo 4

The sidewalks along perimeter of facility on Tufts Street have excessive cross slopes, level changes, gaps and discontinuous surface materials that produce an uneven terrain.
(Photo 4)

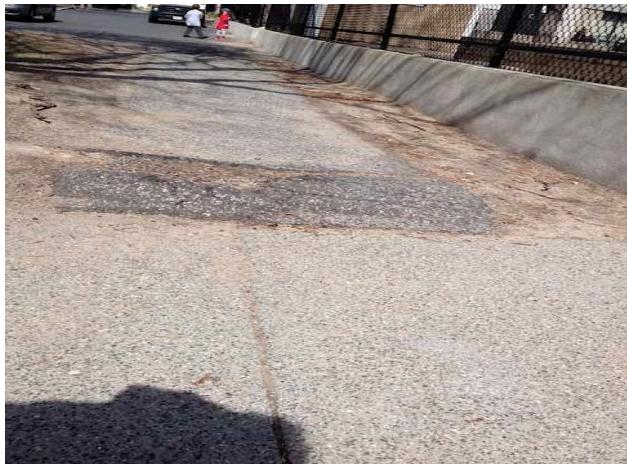
Photo 6

There is no accessible route connecting parking lot to facility accessible entrance. (Photo 6)

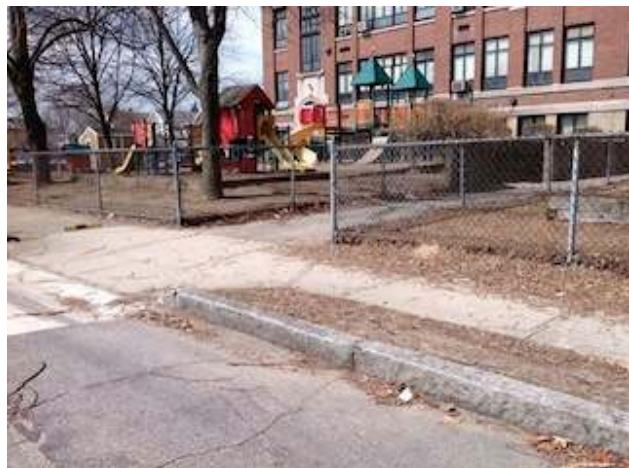
Photo 7

The accessible ramp leading to accessible entrance along Tufts Street needs signage at least as conspicuous as signage at inaccessible entrance. (Photo 7)

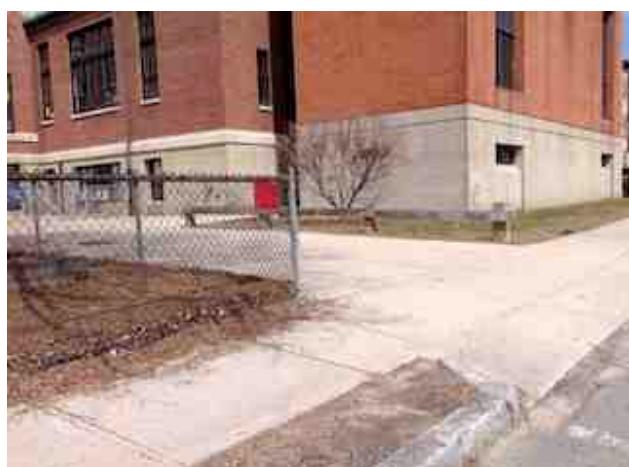
Photo 9

Walkway between Tufts St. and Foster St. passing inaccessible program entrance and picnic table area has vertical level changes over 1/2 inch unbeveled on Tufts St. side and curb ramp with excessive run slope (>13%) on Foster Street side. (Photo 9)

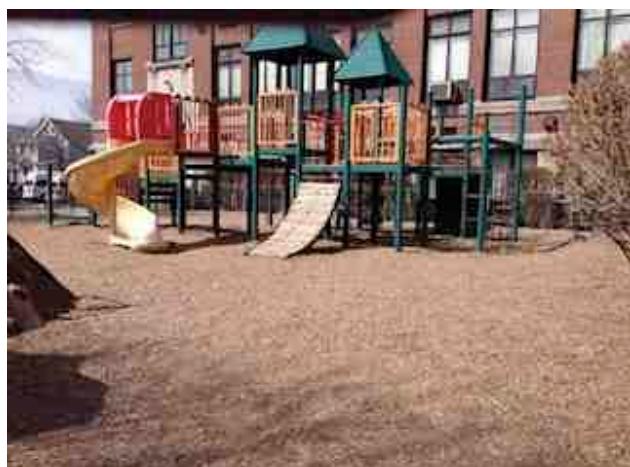
Photo 12

There are more than 20 elevated play components in larger play area and at least 25% are not connected by ramps. None of the ground play components are currently along an accessible route. (Photo 12)

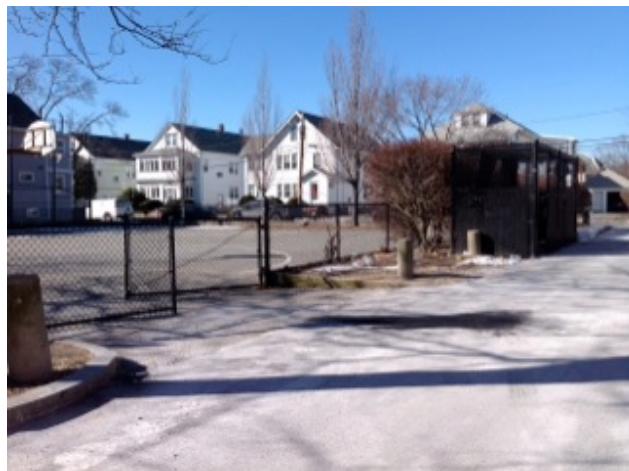
Photo 13

There are 4 entry points into the courts. Entry points closest to accessible parking places have excessive cross or run slopes and ground surface is not smooth. (Photo 13)

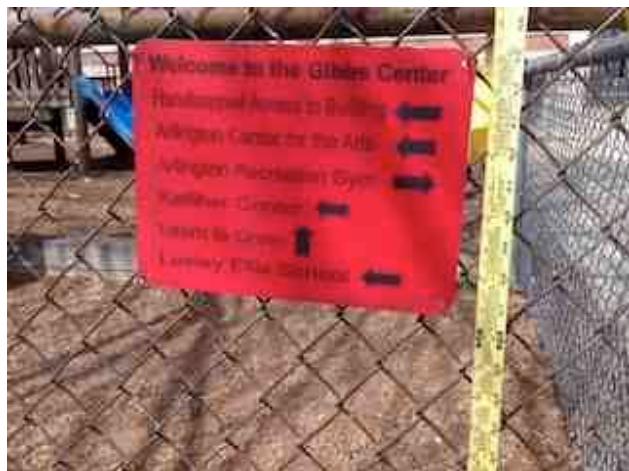
Photo 15

Directional signage mounted along fence around perimeter of facility provides unclear information. (Photo 15)
